Coal Mine Fatal Accident 2003-20

Operator:	Highland Mining Co.
Mine:	Highland 9 Mine
Accident Date:	July 2, 2003
Classification:	Machinery
Location:	District 10, Union Co., Kentucky
Mine Type:	Underground
Employment:	229
Production	12,000 tons/day

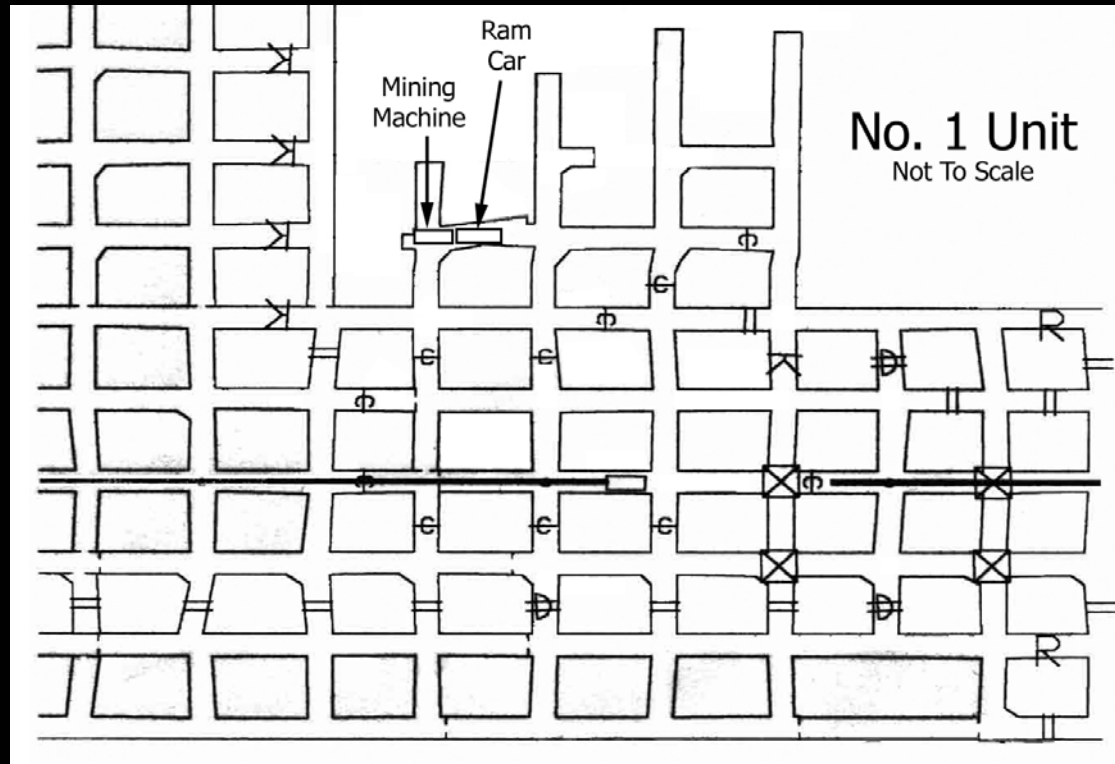
- The No. 1 Unit crew started their shift, on July 2, 2003, at 7:00 a.m.
- The section foreman assigned specific work duties such as repairing ventilation controls and installing roof bolts.
- Production started at approximately 9:00 a.m.
